MARS MRI of the Knee

- Dr. Khushboo Pilania

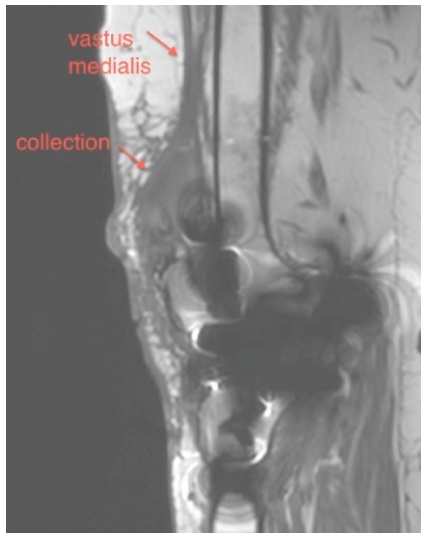
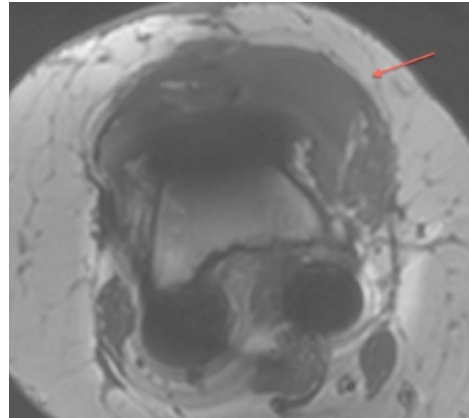
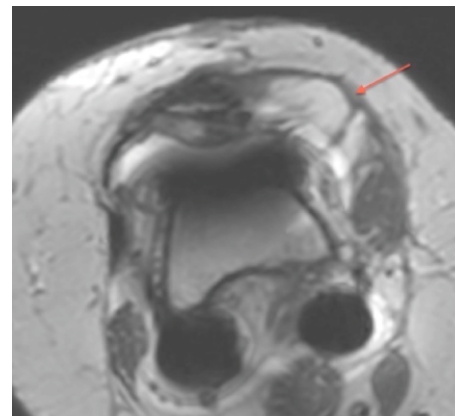
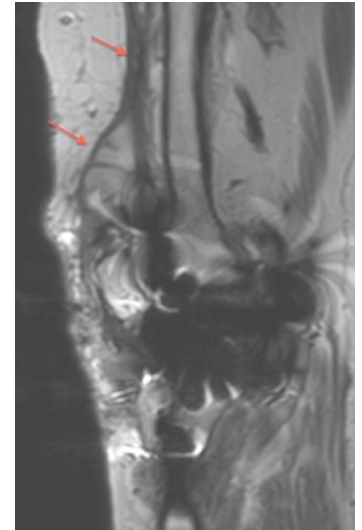
Fig. 1 (A-D): Parapatellar vastus medialis collection. A 65-year old lady post TKR presented with pain and swelling along the medial aspect of the knee. The sagittal (A) and axial (B) T1W images show the periprosthetic bone and soft tissues well. The collection is well seen on the sagittal (A) and axial (B) T2W images.

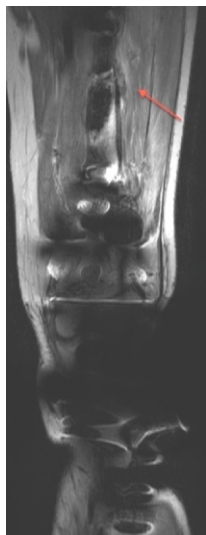
Fig. 2

Fig. 2: Stress fracture. Coronal T2W image shows subtle cortical thickening and irregularity with edema involving the lateral cortex of the femur at the junction of the middle and lower one third with edema of the adjacent vastus lateralis.

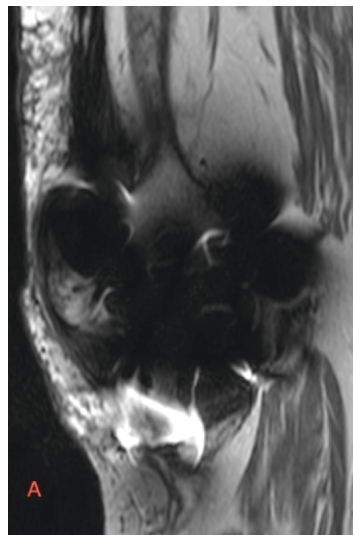
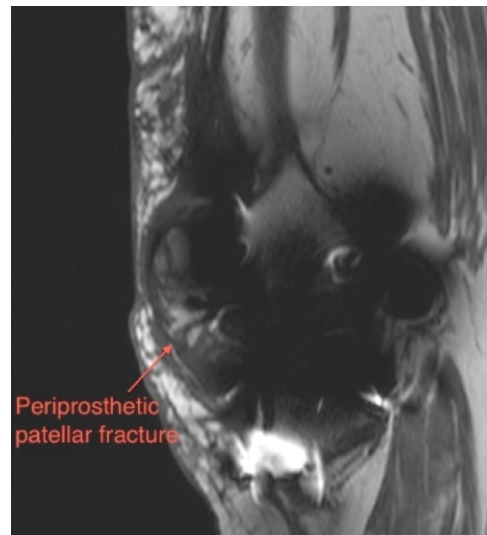
Fig. 3(A-B): Periprosthetic patellar fracture. Sagittal T1W (A) and T2W images show a periprosthetic patellar fracture. The patella is also low lying with thickening and altered signal intensity of the patellar tendon suggestive of patellar tendon fibrosis..

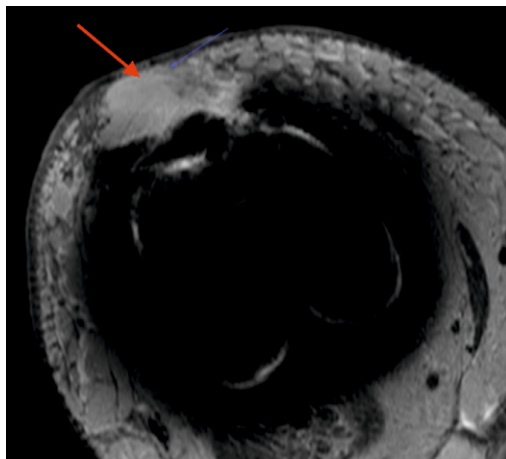
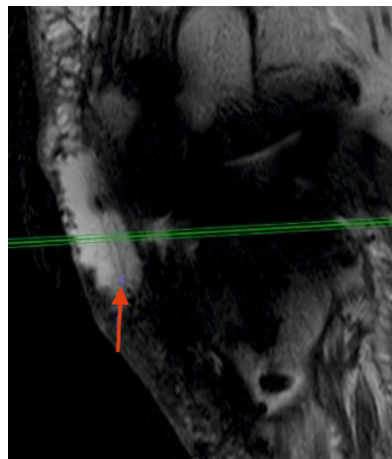
Fig. 4 (A-B): Pre-patellar collection. A 77 years old lady with TKR came with anterior knee pain. Axial (A) and sagittal (B) T2W images show a focal collection in the prepatellar region.

These images have been obtained on a new state-of-the art 3T scanner, the best currently in the country, located in our Lower Parel facility.
